Appendix F: Outfall Evaluation Report

DATE: November 25, 2018

RE: West Plant Outfall Evaluation Report

This report documents the results of an inspection and evaluation of the City of Bremerton's West Plant treatment facility outfall 001 in Sinclair Inlet. An inspection dive and video were conducted on November 8, 2018, covering the outfall from the terminus of the diffuser to the inshore end where the pipeline disappears below mudline.

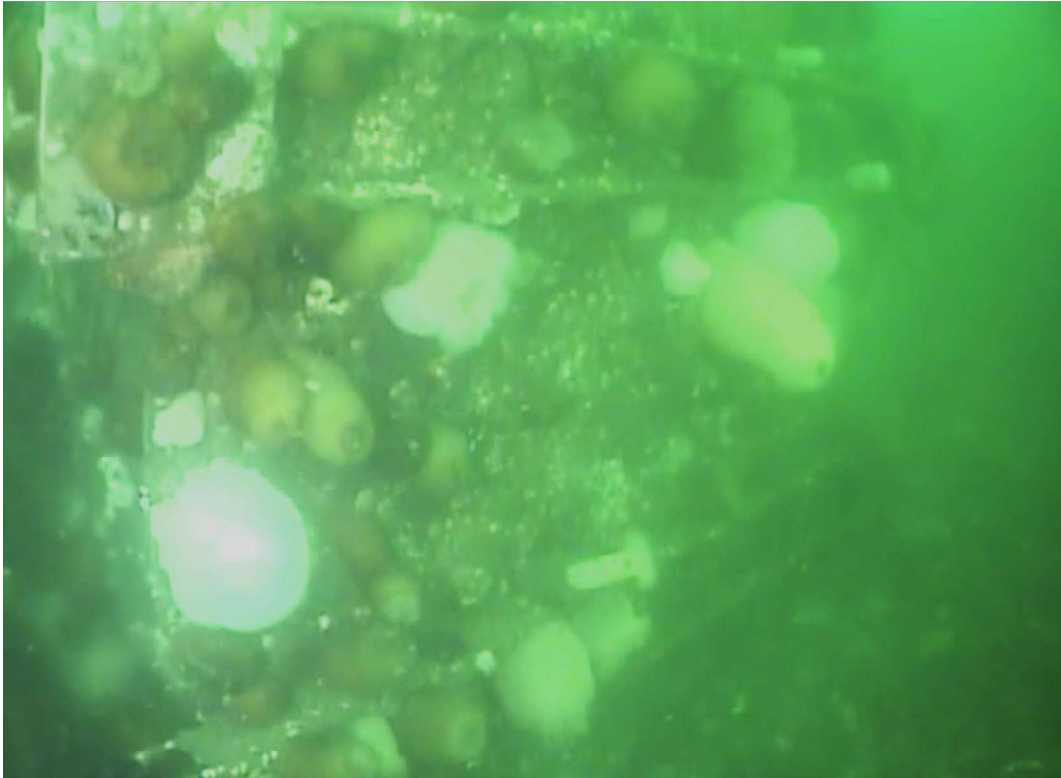
- The diffuser end cap consists of a steel end plate held fast by C-shape mild steel channels running horizontal across the cap from 2- to 10-o'clock position and 8- to 4-o'clock position. The C-channels are restrained by stainless tie rods to lugs on the diffuser pipe. Minor leakage of effluent was observed at the end cap restraints, but this is thought to be inconsequential because the volume is very minor, and the function of this portion of the outfall is to diffuser effluent anyway.

Blind Flange, Offshore End of Outfall Showing C-Channel Restraints

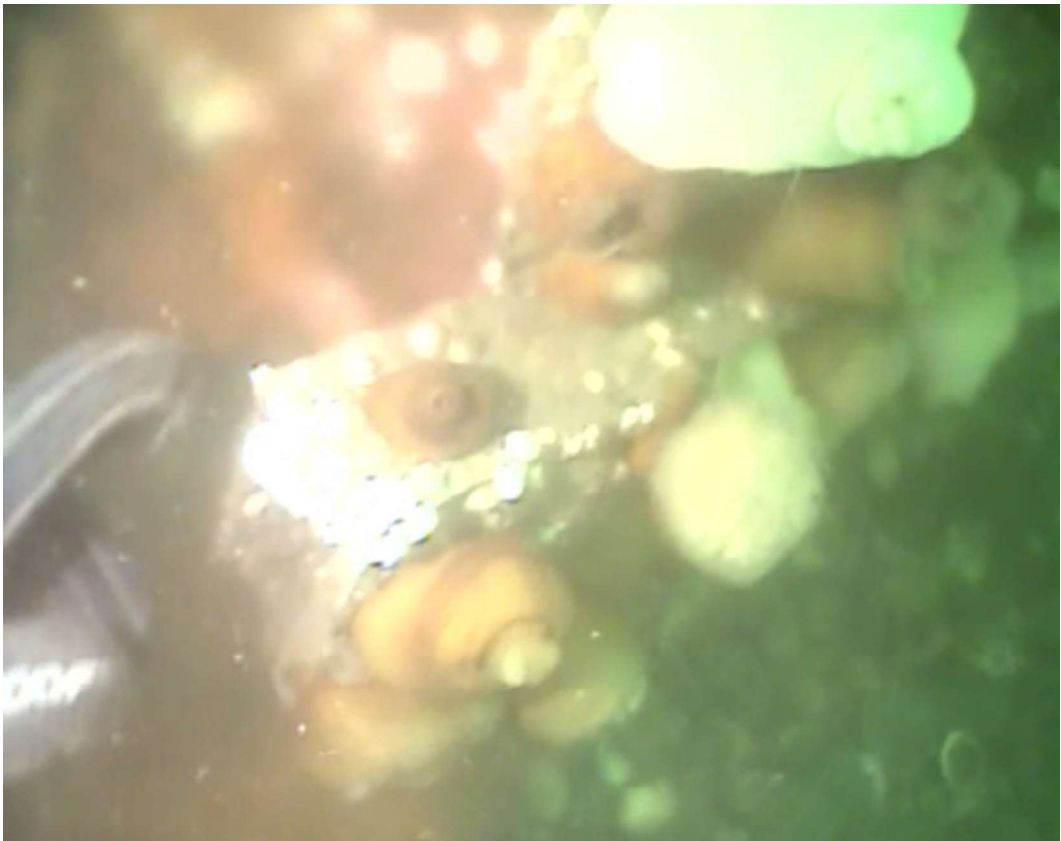
Red Dye Leaking at Blind Flange Restraint, 10-O'Clock Position

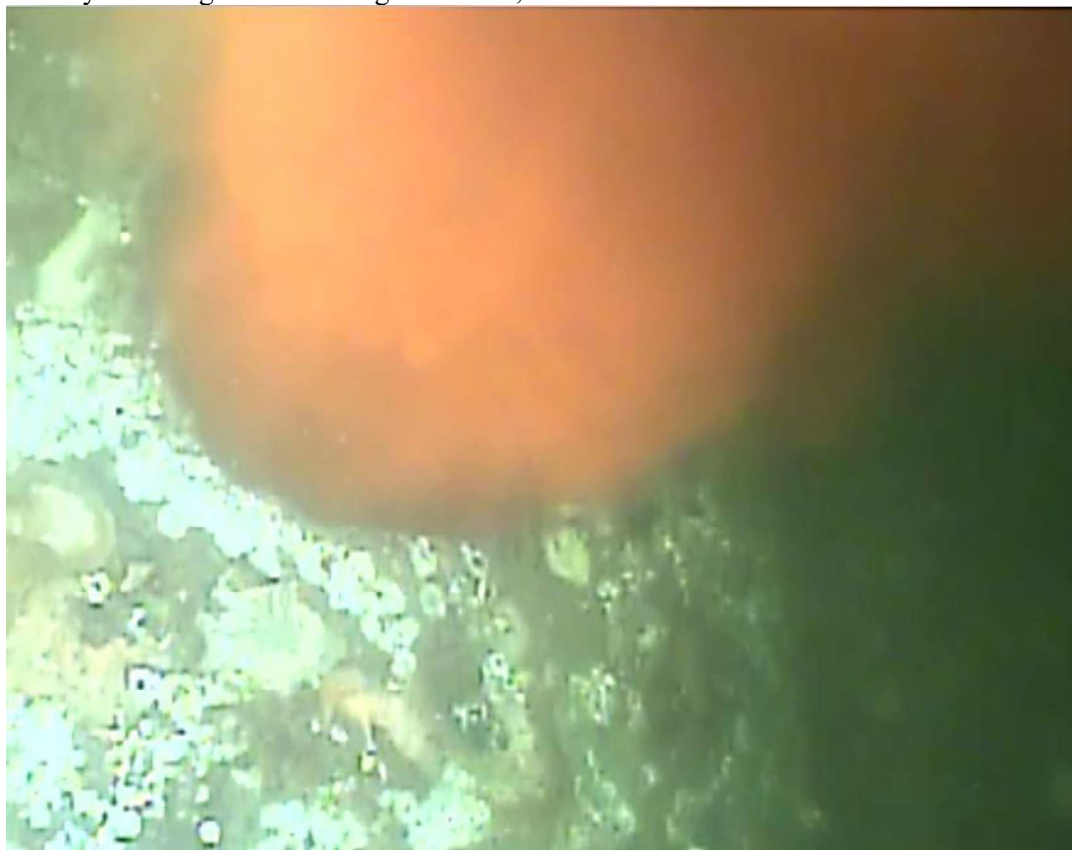
Diffuser Ports. The dyed effluent in the video clearly reveals that all diffuser ports were open and flowing freely. An abandoned fishing net covered several of the offshore ports, but were not visually impeding effluent flow.

Typical Diffuser Port with Red Dye Discharge

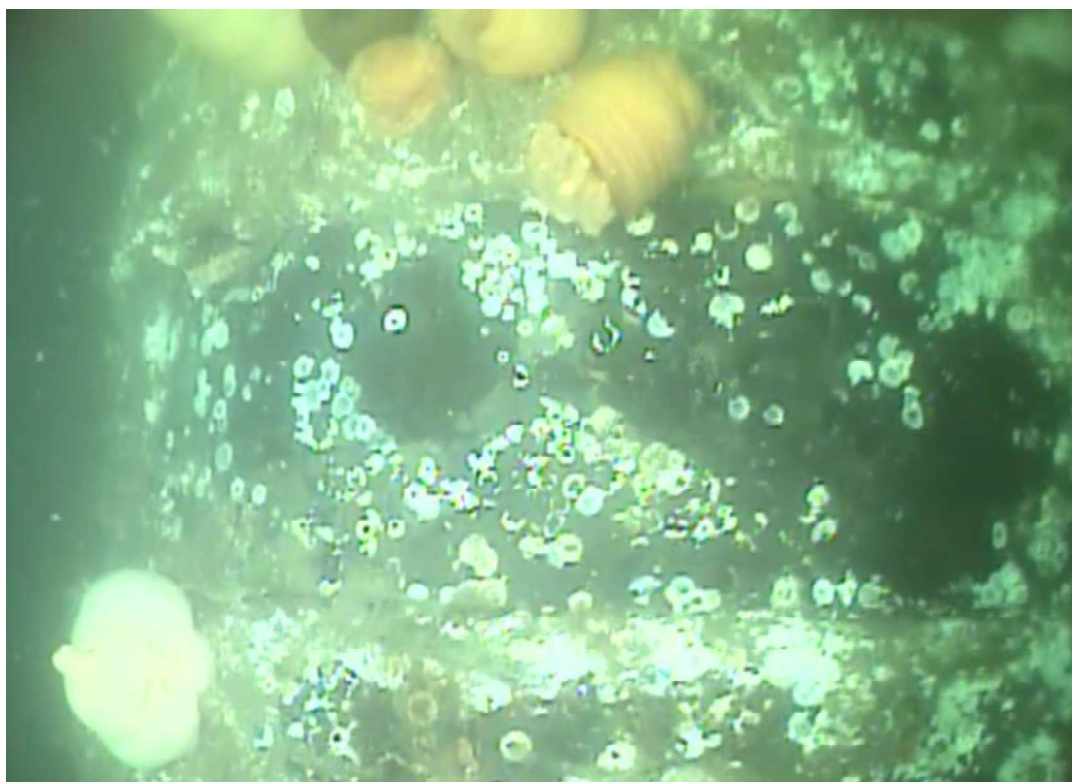
- There were no signs of cracking or damage to the pipe observed at any location. All joints were sealed in grout bands, and no leaking joints were observed.

Typical Joint Grout Injection Band

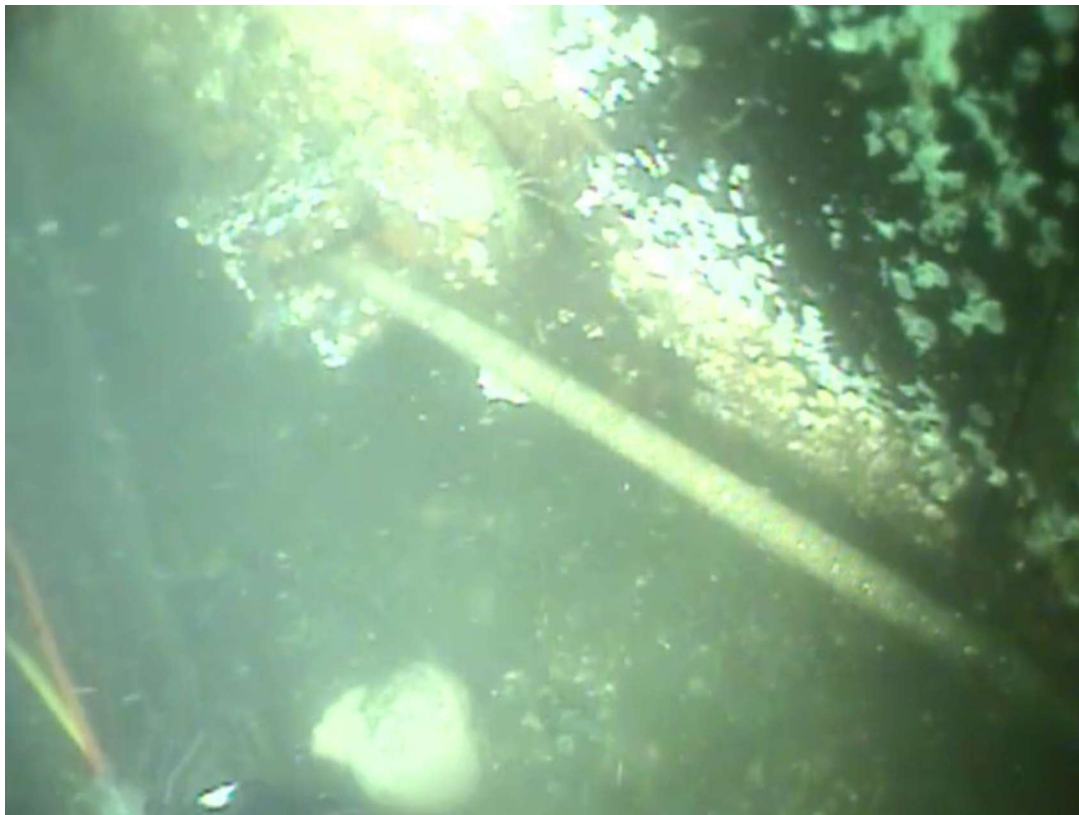
- The joint harnesses consisted of lugs at the springline, on both sides of the pipe, that were drawn together by stainless steel all-thread rods and single nuts. Each joint harness was inspected closely, including several that had all marine growth removed by wire brush. The all-thread was intact and shiny. The nuts retained the hex heads, that could probably accept a hex wrench if there were a need to action the nuts.

Pipe Joint Restraining Rod

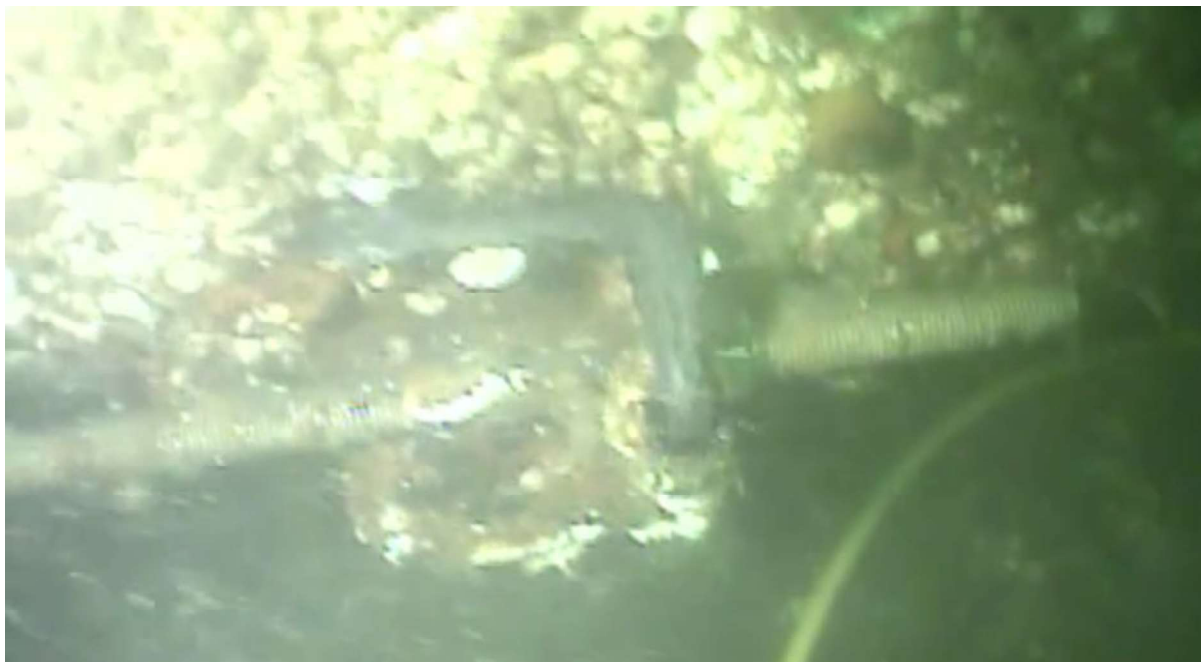
Joint Restraining Lug Attached to RCP Pipe
