# **GORST CREEK WATERSHED STORMWATER CAPITAL IMPROVEMENT PLAN**

## **Technical Memorandum**

For: City of Bremerton, WA

September 2013

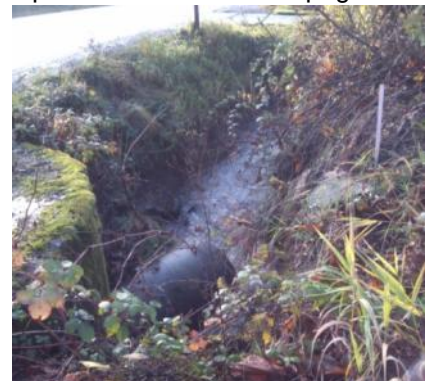
**Photo 1** Belfair Valley Road 36 IN Culvert crosses the roadway at the Winner's Circle Bar and Grill

*Site 2, Problem 2, Unnamed Tributary Flooding Deficiency* - The unnamed tributary begins at the northeast corner of the basin and flows south and then east along the north side of W. Belfair Valley Road in 7-foot-wide by 8-foot-deep ditches. The tributary crosses the road in a 36-inch-diameter concrete culvert into one of the ditches and then outlets through a 36-inch culvert to the southeast into Sinclair Inlet across Hwy 3. The ditch gets overwhelmed with the combination of rising tides and heavy rain at this Hwy 3 sag location. Flooding in this area is frequent and severe in impact. Business for Winners Circle Bar and Grill shuts down when the lot floods and the road is closed by the high water. Tool Liquidators, the Winner's Circle Bar and Grill, and adjacent residential properties to the west reported ditch overflow flooding up to the foundation footing of their buildings during high tides and high

intensity storms. Tool Liquidators has had up to 18 inches of flood waters within their building. The Navy City Metals yard has occasionally flooded next to these ditches. Finally, a discharging street drainage line/inlet to the northeast silts up from reverse pipe flow sediment in the front of Tool Liquidators.

*Unnamed Tributary Discussion and Recommendations:* Flooding of the multiple businesses and residences is closely related to the Hwy 3 flooding road closures discussed for Site 4. Flooding of business and residences is common and severe enough that drainage subreach creek source controls and outlet culvert design of the ditch flow should be carefully reviewed.

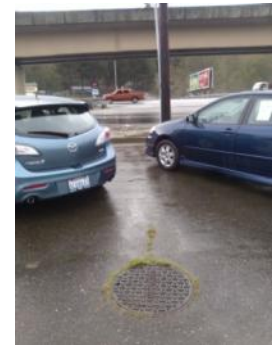
**Photo 2** At south culvert end, looking south across SR 16 toward unnamed tributary

A 270 LF by 18-inch CMP culvert runs from south to north under the Subaru car lot and into Sinclair Inlet (see Appendix B for the County's storm sewer system). A sink hole developed on the northeast side of the Peninsula Subaru property in their paved parking area over the top of this culvert. It appears that the CMP culvert has corroded and has created the sink hole as a result of culvert piping or exterior flows undermining and eroding out the bedding around the pipe. The outlet for this pipe is set roughly 10 feet below the parking area and includes a tee diffuser at or below the water level depending on the tides. A culvert and a storm sewer trunk line drains into this culvert on the south end. The storm sewer is adjacent to Hwy 16. The culvert crosses Hwy 16 and picks up the flow from an unnamed tributary. Proper drainage for these connecting pipes is dependent on the repair of the Subaru culvert.

Capacity of this undermined culvert may be reduced and might be affecting the ability to drain runoff away from Hwy 16. However, flow upstream in the unnamed tributary appeared to be unencumbered at the culvert entrance in observations during recent near record rains. Public comments report that stormwater is undermining many of the roads in the vicinity of Feigley Road and the frontage road on the south side of Hwy 16 as discussed with flood deficiencies for Site 10. Common sediment accumulations are noted to clog road drainage catch basins in this area. WSDOT, Subaru, and the City of Bremerton need to coordinate to address the underground erosion and capacity issues associated with this culvert.

*Discussion and Recommendations:* Repair of the culvert is complicated by a claim by the owner that the culvert is set within an easement and they are not responsible for its repair. The City of Bremerton does not claim ownership nor honor the maintenance responsibility for a storm drainage line within the easement. The issue of maintenance will need to be resolved before the repair can be completed.

*Estimate:* Preliminary design and coordination scope includes multi-jurisdictional and private owner coordination; survey services to include resolving land dispute; and design of culvert replacement. Construction scope assumes replacing the existing culvert with 270 LF of 48-inch-wide arch culvert.

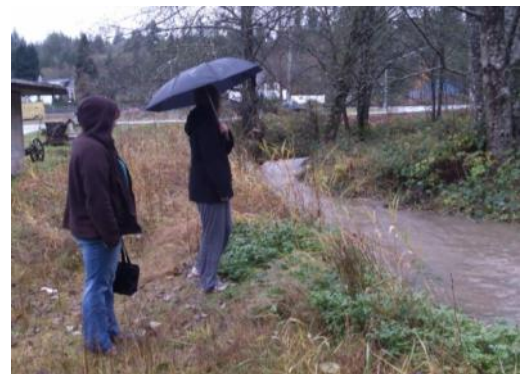
**Photo 3** Looking south

Sam Christopherson Road Culvert - A drainage complaint was received by Kitsap County Public Works that the two residences flood due to installation of a 24-inch private driveway culvert upstream along Sam Christopherson Road. The County inspected the site and noted that the culvert and driveway were on private property.

The Sam Christopherson Road culvert is located west of the Waldbillig properties. No action was taken by the County after determining that the culvert was on private property. It is not apparent how a driveway culvert would cause flooding on any property other than the adjacent property on Sam Christopherson Road. More investigation is needed to determine if culvert clogging was the issue or not.

*Discussion and Recommendations:* The ditch flow is mostly restricted by the upstream 36-inch-diameter culvert(s) that constrain the maximum flow volumes coming from Hwy 3 and the unnamed creek. Since the ditch flow overtops the banks, the capacity of the ditch will need to be increased and sized based on the outlet flows picked up by the ditch to prevent flooding of the properties. Fish habitat and environmental impacts will need to be assessed.

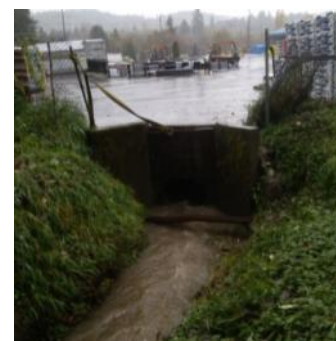
**Photo 4** Looking south at 36-inch culvert (in shadow)

Kitsap County Public Works and the Kitsap County Public Health District noted previous flooding from an upstream unnamed tributary that caused property damage in the lumber yard from an overwhelmed 36-inch diameter steel CMP culvert entrance upstream of the paved lot. Flows enter the site from an upstream unnamed stream 12270264775270 from the south (see photo 4). The headwater of the unnamed stream is just downstream of the Port Orchard UGA near the McCormick Woods development.

To avoid flooding, the manager has to maintain a screen at the culvert entrance that prevents debris from entering the 350 LF by 36-inch-diameter culvert pipe. Silt has not been an issue with the culvert. In the *Existing Fish Passage Barriers Technical Memorandum*, the culvert is classified as a fish barrier due to 1-foot-high peak flows and a length longer than 100 feet. The obstacle rating was evaluated as low to medium. The culvert is downstream of 5,000 LF of potential habitat.

*Discussion and Recommendations:* Past and potential flooding from this private culvert predominantly is a threat mostly to damage of material stored on this private site. However, flows draining across the paved lot could end up quickly flowing north across Hwy 16. The business has taken preventative measures by removing the culvert screen guard during heavy rains that collect debris and dams up the stream but also prevents debris from entering the culvert. Flooding caused by debris clogging can be mitigated by using a pool near the culvert entrance to slow velocities and snag debris before lodging in the inlet.

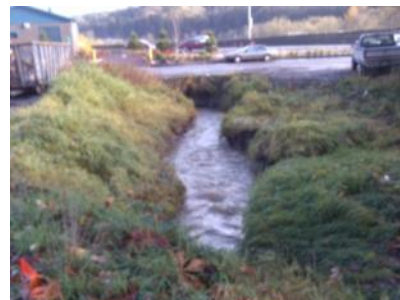
**Photo 5** Looking southeast at ditch and 36-inch culvert crossing west of Hwy 3

This site is monitored by Ecology through an industrial permit. The ditch on the north side of W. Belfair Valley Road (see photo 5) is connected to a second continuing downstream ditch by a 36-inch culvert crossing under the road. This ditch is drained by a 36-inch culvert crossing Hwy 3 to Sinclair Inlet. The second ditch (see photo 4) is adjacent to this active metal recycling facility. Backwater from high tides and heavy rainfall floods the properties noted in Site 2 and the yard at Navy City Metals. Employees report that flooding as deep as 3 feet has been seen in the yard. All yard drainage leaves through an oil/water separator and is released into the ditch by a 6-inch pipe. Metal laden runoff released into Sinclair Inlet is a concern because copper and zinc levels are already high.

*Discussion and Recommendations:* The water quality for this site is the responsibility of Ecology. The flooding of this site is related to solving the flooding problems described for Gorst Creek at the outlet with Sinclair Inlet as discussed for Site 4. Investigation should include discussions with the property owner. A backflow preventer with the 4-inch outlet pipe with their oil/water separator may help relieve flooding. The grades surrounding the site should be reviewed to see if the site is lower than the creek channel flood levels and straight-forward flood mitigation solutions should be reviewed.

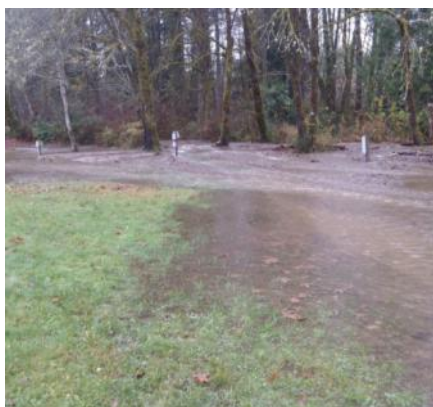
**Photo 6** Creek bank overflow from behind first row of trees upstream of the Association's property

Fish passage problems are encountered in Parish Creek downstream of the W. Belfair Valley Road crossing and bank overtopping problems occur from Parish Creek upstream of the road crossing within the Kitsap Square Dance Association property. During high flows, Parish Creek jumps the narrow and shallow creek bed channel into surrounding floodplain areas to the east, approximately 400 feet upstream of the W. Belfair Valley Road culvert. Over the years, high flow events have brought sediment into this area causing loss of the main channel due to infilling, and creating braiding and broad floodplain overflows into the adjacent areas (see photos 17 and 18). From this location, floodplain drainage tends to flow through the Kitsap Square Dance Association gravel parking lot to the northeast corner where it crosses W. Belfair Valley Road. The sheet flow flows down both road shoulders toward the road's sag point at the Gorst Creek crossing, 800 feet to the east.

For flows that remain in Parish Creek west of the dance hall facility, the main channel flows through a 5-foot-diameter steel CMP culvert under the W. Belfair Valley Road. This culvert outlet is directed into a concrete channel constructed with 12-inch weir drops.

*Discussion and Recommendations:* The culvert fish passage problem and creek flooding problems and solution alternatives are discussed in a technical memorandum called *Parish Creek Fish Habitat Improvement* (AECOM 2012). The obstacle rating for this culvert was evaluated as medium. Barrier elements include 1-foot weir drops without notches, slope culvert, and high velocities at peak flows. This culvert is downstream of 7,400 LF of potential habitat.

The reason sediment is infilling Parish Creek needs to be identified. Soils are known to be susceptible to erosion and the site should be observed for evidence of slides or other tell tale signs of where the sediment is originating. Property development at the headwaters should be reviewed and analyzed for the possibility it is increasing Parish Creek flow rates. The Sunny Slope development, adjacent to Parish Creek, was constructed without any stormwater controls.

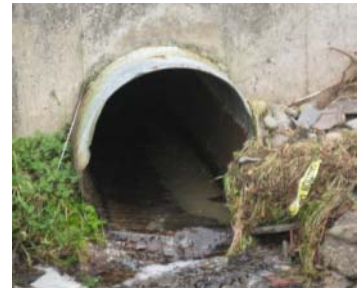
**Photo 16** Culvert 12 inlet

*Discussion and Recommendations:* This 36-inch-diameter CMP culvert is the same culvert discussed under Site 12 and is associated with the Washington Cedar Lumber Yard. As discussed with Sites 24 and 25, the inlet shown in photo 16 is the beginning of roughly 640 LF of culvert and storm sewer pipe that outlets near the Waldbillig properties. The outlet drainage flow of this culvert enters directly into the inlet of the culvert mentioned in Site 25. The only option for improving fish passage is to reroute the stream around the current property and avoid the culvert running through the business property. The private owner will be responsible for adhering to WDFW fish passage compliance.

*Estimate:* For estimating purposes, the design scope includes upstream hydrologic modeling. A biological assessment will be required as part of the HPA permit. The construction scope includes replacing the culvert with a rerouted 300 LF of 5-foot-wide creek bed and 140 LF by 58-inch-wide arch culvert adjacent to the fire station and parking lot. Unnamed Creek 1227026475270 will be rerouted around the Washington Cedar Lumber Yard.

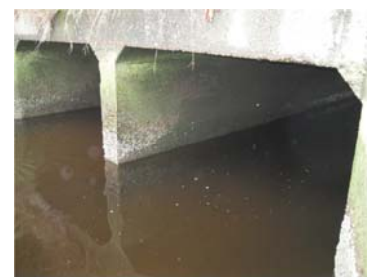
Photo 19 Culvert 17

*Discussion and Recommendations:* This culvert is discussed with Site 4 and is the responsibility of WSDOT.

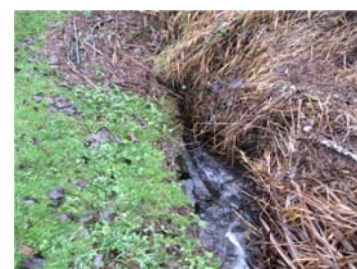
Photo 20 Culvert 18 inlet

*Discussion and Recommendations:* As discussed for Site 3, the repair of the Subaru portion of the receiving culvert is complicated by the owner's claim that the culvert is set within an easement and it is not responsible for the culvert's repair. WSDOT is responsible for this culvert.

*Estimate:* For estimating purposes, the design scope includes upstream hydrologic modeling and a conceptual design study. A biological assessment will be required as part of the HPA permit. Construction estimate scope includes 210 LF of 50-inch-wide by 31-inch arch culvert.
