Exhibit 3A
WDFW Fish Passage
Inventory - Brentwood
Culvert

Site Description Report

Level A Culvert Assessment Report

Site ID: 996510	Stream: Ostrich Cr	WRIA: 15.0226	
Latitude: 47.5733433	Tributary To: Ostrich Bay	Fish Use Potential: Yes	
Longitude: -122.683337

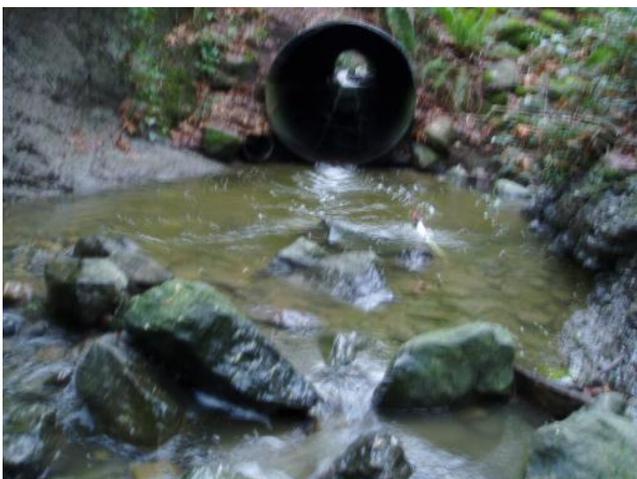
Culvert Details						Level A Parameters						
ID	Shape	Material	Span	Rise	Length	WDIC	Apron	WSDrop	Location	Countersunk	Backwater	Slope (%)
1.1	RND	CST	1.52	1.52	24.50	0.04	NO	0.06		No		3.30

Channel Description	
Toe Width (m):	<input type="text"/>
Average Width (m):	<input type="text" value="3.40"/>
Culvert/Stream Width Ratio:	<input type="text" value="0.45"/>
Plunge Pool	
Length (m):	<input type="text" value="4.50"/>
Max Depth (m):	<input type="text" value="0.53"/>
OHW Width (m):	<input type="text" value="4.00"/>
Road	
Fill Depth (m):	<input type="text" value="3.00"/>

Assessment Results			
Barrier:	<input type="text" value="Yes"/>	Passability (%):	<input type="text" value="0"/>
Reason:	<input type="text" value="Slope"/>	Fishway Present:	<input type="text" value="No"/>
		Method:	<input type="text" value="Level A"/>
		Recheck:	<input type="text"/>

Comments
inlet has 0.40m infall drop.
