# West Kitsap Way Planning Study

### Pavement Investigation Analysis

Attn: **John Davies**  
Subject: **West Kitsap Way Planning Study  
Pavement Investigation  
Bremerton, Washington**

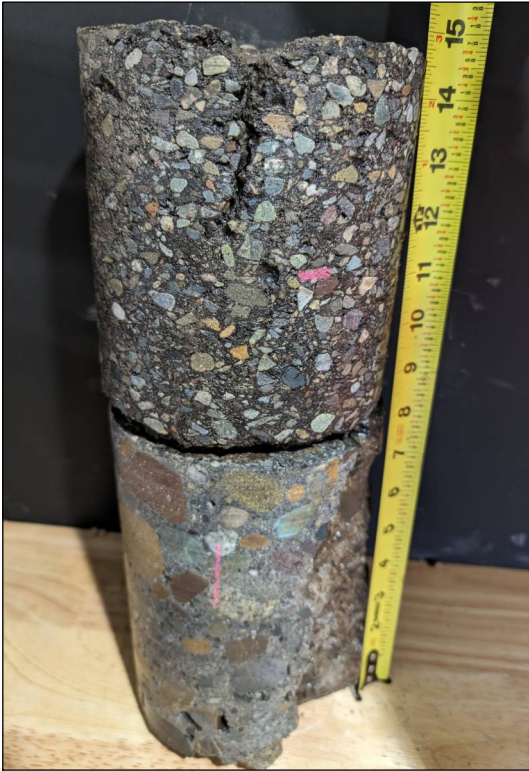
PAVEMENT CORE PHOTO

DEPTH (feet)	SYMBOL	USCS SOIL CLASS.	DESCRIPTION	SAMPLE TYPE	SAMPLE NUMBER	MOISTURE CONTENT(%)	OTHER TESTS
0			6.5 inches Hot Mix Asphalt. 2 Lifts: 3.25" x 3.25" Cored on medium severity longitudinal crack. Lifts are bonded. Cracked through upper lift. Lower lift has a hairline crack.  (HMA)				
1			8 inches Portland Cement Concrete. Cracked through. Poor condition. (PCC)				
2		GP GM	Medium dense, brown, sandy, rounded GRAVEL with silt, moist. (FILL)				
3			Corehole was terminated at 2 feet below ground surface. No groundwater seepage was observed during the exploration.

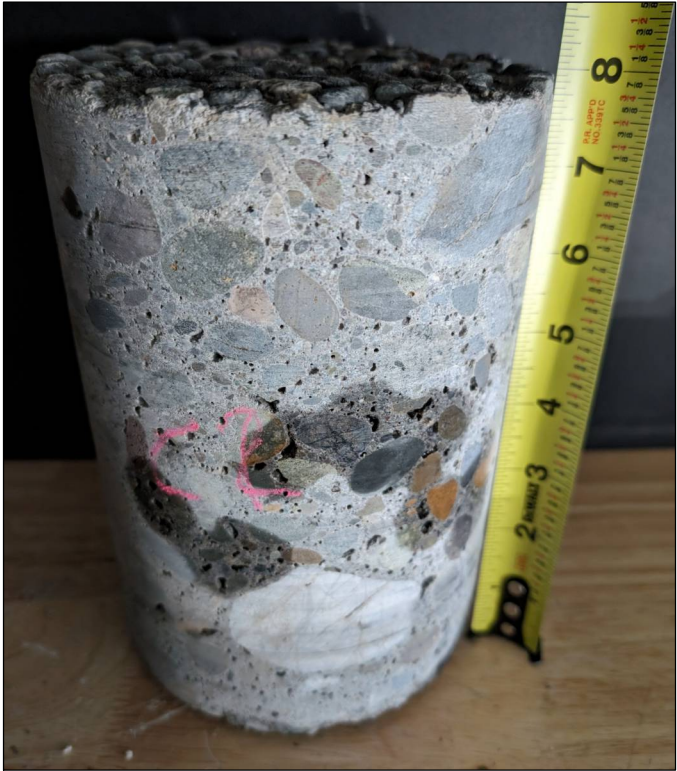
PAVEMENT CORE PHOTO

7.75 inches Portland Cement Concrete. No cracking at this location. Good condition. (PCC)				
1

GM	Dense, brown, silty, sandy, fine to coarse, rounded GRAVEL, moist. (FILL)				
2	Corehole was terminated at 1.5 feet below ground surface. No groundwater seepage was observed during the exploration.						
3

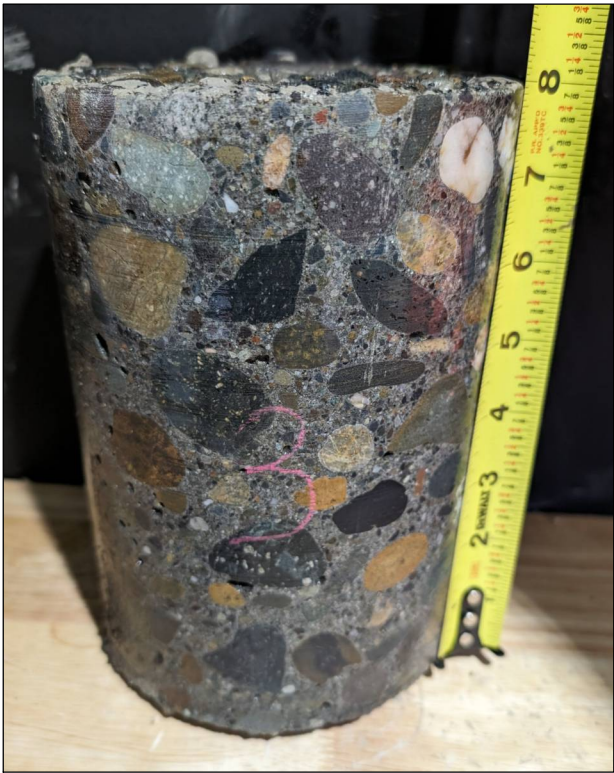
PAVEMENT CORE PHOTO

DEPTH (feet)	SYMBOL	USCS SOIL CLASS.	DESCRIPTION	SAMPLE TYPE	SAMPLE NUMBER	MOISTURE CONTENT(%)	OTHER TESTS
0			8 inches Portland Cement Concrete. No cracking at this location. Good condition. (PCC)				
1		GP GM	Medium dense, brown, sandy, rounded GRAVEL with silt, moist. (FILL)				
2			Corehole was terminated at 1.75 feet below ground surface. No groundwater seepage was observed during the exploration.				
3

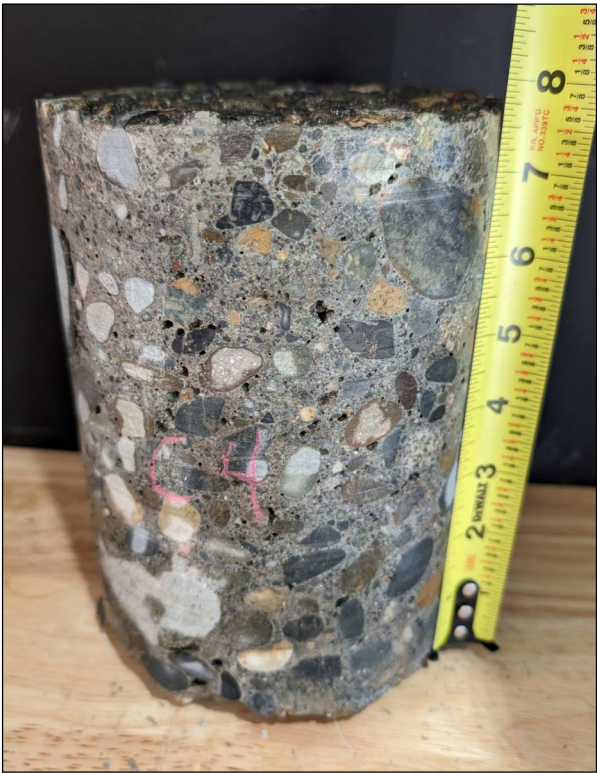
PAVEMENT CORE PHOTO

DEPTH (feet)	SYMBOL	USCS SOIL CLASS.	DESCRIPTION	SAMPLE TYPE	SAMPLE NUMBER	MOISTURE CONTENT(%)	OTHER TESTS
0			7.75 inches Portland Cement Concrete. No cracking at this location. Good condition. (PCC)				
1		SM	Loose to medium dense, olive brown, silty SAND with fine gravel, moist. (FILL)  Becomes dense.				
2							
3

Corehole was terminated at 2 feet below ground surface. No groundwater seepage was observed during the exploration.

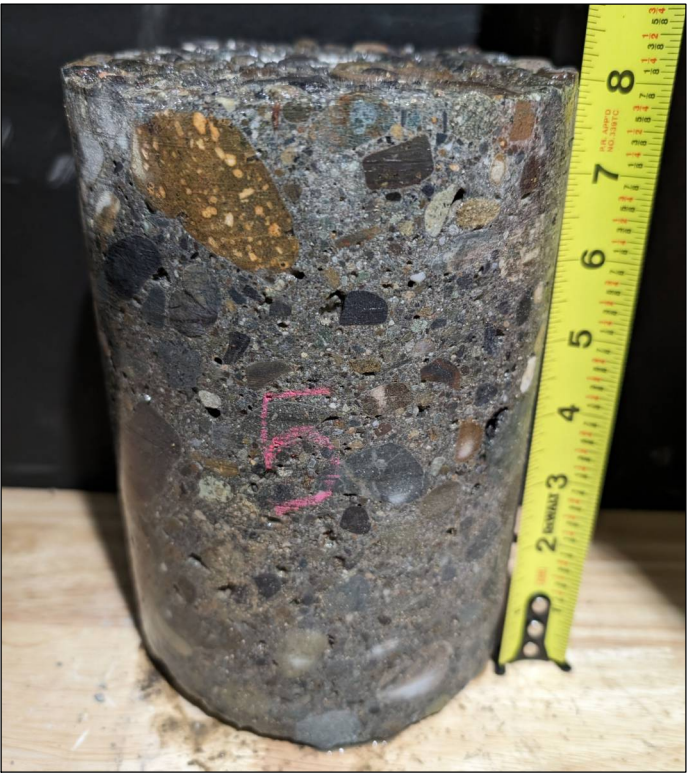
PAVEMENT CORE PHOTO

8 inches Portland Cement Concrete. No cracking at this location. Good condition. (PCC)				
1

GM	Medium dense to dense, brown, silty, sandy, rounded GRAVEL, wet. (FILL)				
2			Corehole was terminated at 1 foot below ground surface due to heavy groundwater seepage. Groundwater seepage was observed at 0.7 feet below ground surface.				
3

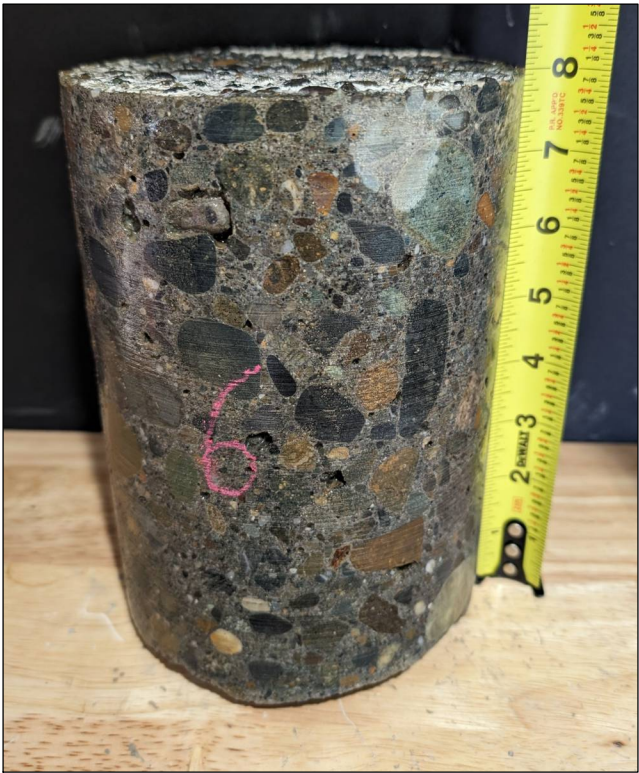
PAVEMENT CORE PHOTO

DEPTH (feet)	SYMBOL	USCS SOIL CLASS.	DESCRIPTION	SAMPLE TYPE	SAMPLE NUMBER	MOISTURE CONTENT(%)	OTHER TESTS
0			8 inches Portland Cement Concrete. No cracking at this location. Good condition. (PCC)				
1		GM	Medium dense, brown, silty, sandy, rounded GRAVEL with scattered cobbles, moist. (FILL)				
2			Corehole was terminated at 2 feet below ground surface. No groundwater seepage was observed during the exploration.				
3

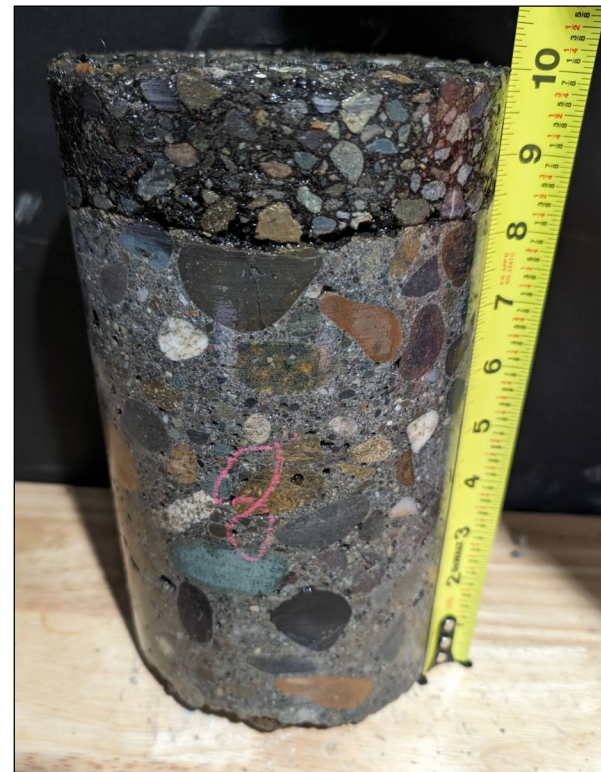
PAVEMENT CORE PHOTO

DEPTH (feet)	SYMBOL	USCS SOIL CLASS.	DESCRIPTION	SAMPLE TYPE	SAMPLE NUMBER	MOISTURE CONTENT(%)	OTHER TESTS
0			2 inches Hot Mix Asphalt. 1 Lift. No cracking at this location. Bonded to PCC below. (HMA)				
			8 inches Portland Cement Concrete. Good condition. (PCC)				
1	GP GM		Medium dense, brown, sandy, rounded GRAVEL with silt, moist. (FILL)				
2	ML		Medium stiff, gray, fine sandy SILT, moist to wet. (CONTINENTAL GLACIAL OUTWASH)				
3			Corehole was terminated at 2 feet below ground surface. Slow groundwater seepage was observed at 2 feet below ground surface.

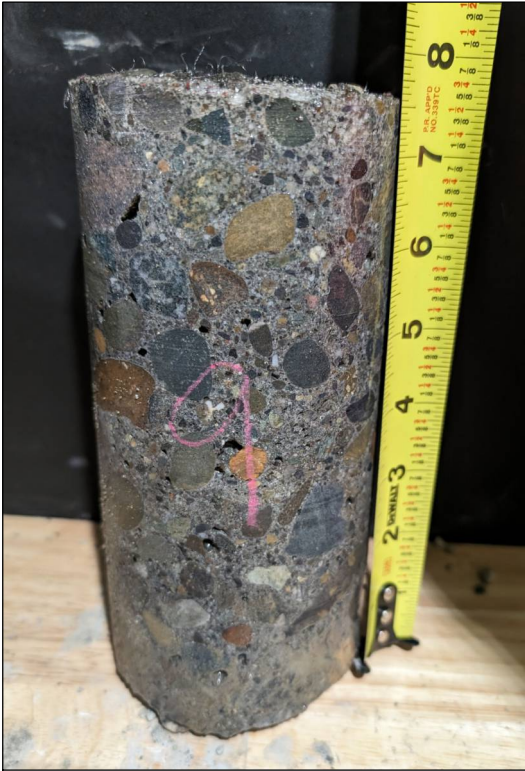
PAVEMENT CORE PHOTO

DEPTH (feet)	SYMBOL	USCS SOIL CLASS.	DESCRIPTION	SAMPLE TYPE	SAMPLE NUMBER	MOISTURE CONTENT(%)	OTHER TESTS
0			7.5 inches Portland Cement Concrete. No cracking at this location. Good condition. Unconfined compressive strength = 9400 psi. (PCC)		S-1	Compression	
		GP	Medium dense, brown, sandy, fine, rounded GRAVEL, moist.				
		GM	(FILL)				
1		SM	Medium dense, olive brown, silty SAND with scattered fine gravel, moist.				
		ML	Medium stiff, gray, fine sandy SILT, moist. (CONTINENTAL GLACIAL OUTWASH)				
2			Corehole was terminated at 1.75 feet below ground surface. No groundwater seepage was observed during the exploration.				
3

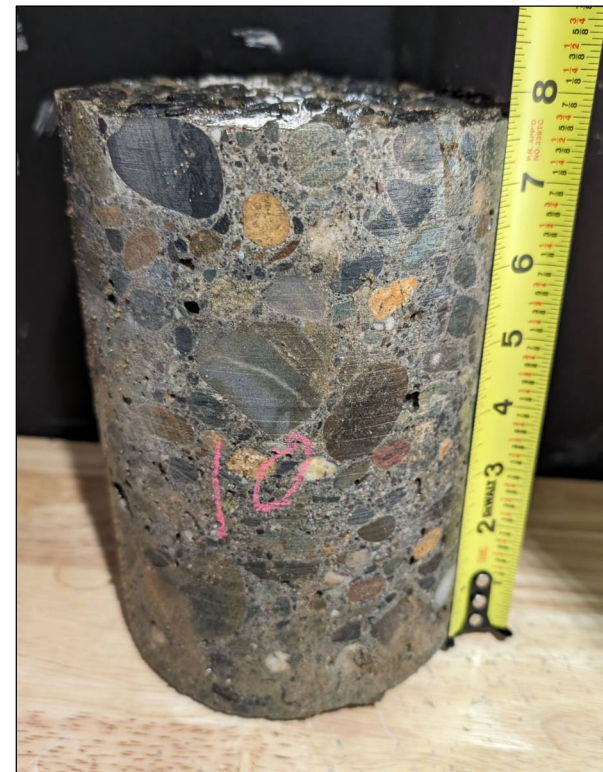
PAVEMENT CORE PHOTO

DEPTH (feet)	SYMBOL	USCS SOIL CLASS.	DESCRIPTION	SAMPLE TYPE	SAMPLE NUMBER	MOISTURE CONTENT(%)	OTHER TESTS
0			7.75 inches Portland Cement Concrete. No cracking at this location. Good condition. (PCC)				
1	GP GM		Medium dense, brown, sandy, rounded, fine to coarse GRAVEL with silt, moist. (FILL)				
2	SM		Medium dense, olive brown, silty, fine SAND, moist. (CONTINENTAL GLACIAL OUTWASH)				
3			Corehole was terminated at 2 feet below ground surface. No groundwater seepage was observed during the exploration.

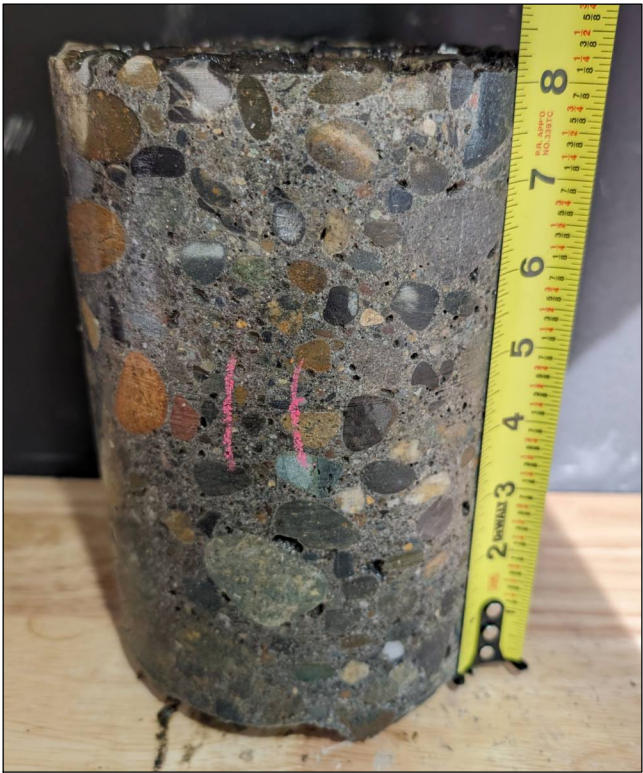
PAVEMENT CORE PHOTO

8.25 inches Portland Cement Concrete. No cracking at this location. Good condition. (PCC)				
1

GP	Medium dense, brown, sandy, fine to coarse, rounded GRAVEL, moist. (FILL)				
2

SM	Medium dense, gray and brown mottled, silty, fine SAND, moist. (CONTINENTAL GLACIAL OUTWASH)				
3			Corehole was terminated at 2 feet below ground surface. No groundwater seepage was observed during the exploration.

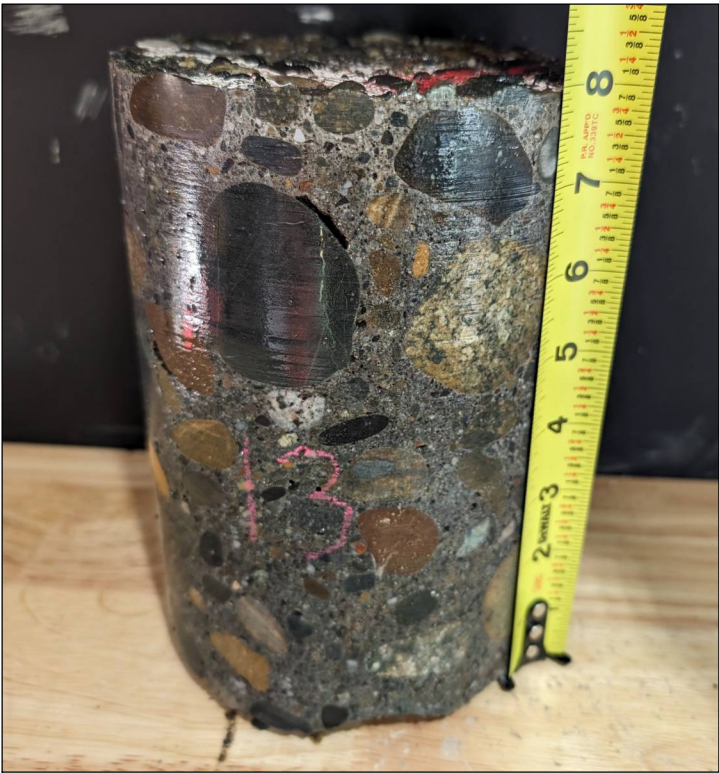
PAVEMENT CORE PHOTO

DEPTH (feet)	SYMBOL	USCS SOIL CLASS.	DESCRIPTION	SAMPLE TYPE	SAMPLE NUMBER	MOISTURE CONTENT(%)	OTHER TESTS
0			8 inches Portland Cement Concrete. No cracking at this location. Good condition. (PCC)				
		GP GM	Dense, brown, sandy, rounded GRAVEL with silt, moist. (FILL)				
1		GM	Dense, brown, silty, sandy, rounded GRAVEL, moist.				
2			Corehole was terminated at 1.6 feet below ground surface. No groundwater seepage was observed during the exploration.				
3

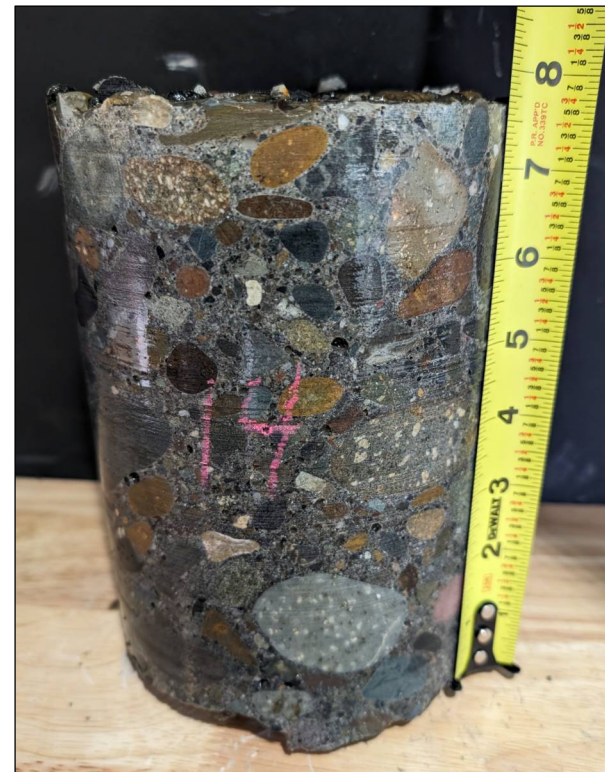
PAVEMENT CORE PHOTO

DEPTH (feet)	SYMBOL	USCS SOIL CLASS.	DESCRIPTION	SAMPLE TYPE	SAMPLE NUMBER	MOISTURE CONTENT(%)	OTHER TESTS
0			7.75 inches Portland Cement Concrete. No cracking at this location. Good condition. (PCC)				
1	GP		Medium dense, brown, sandy, fine to coarse, rounded GRAVEL, moist. (FILL)				
2	GM		Medium dense, brown, silty, sandy, fine to coarse, rounded GRAVEL, moist.				
3			Corehole was terminated at 1.8 feet below ground surface. No groundwater seepage was observed during the exploration.

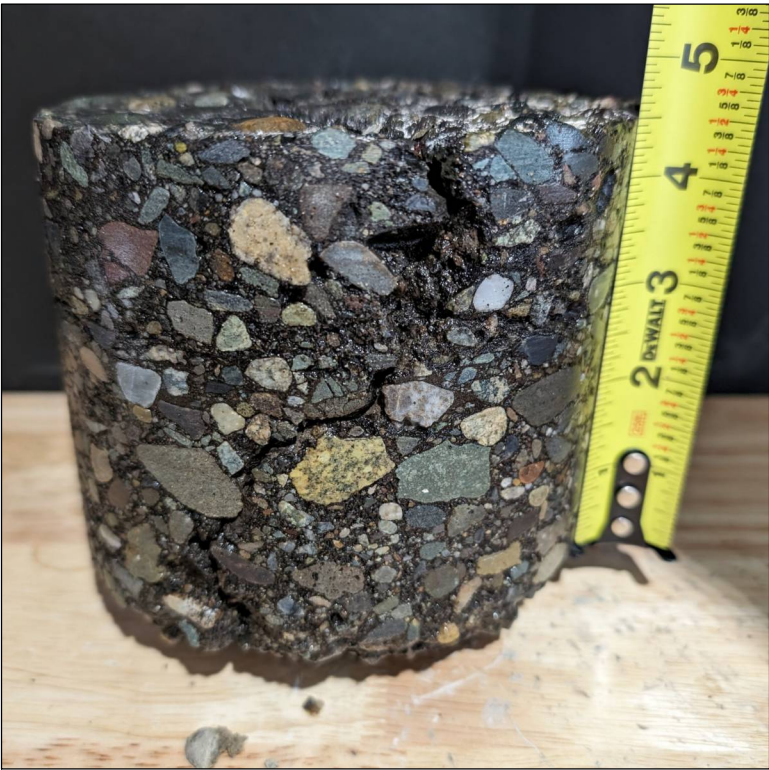
PAVEMENT CORE PHOTO

DEPTH (feet)	SYMBOL	USCS SOIL CLASS.	DESCRIPTION	SAMPLE TYPE	SAMPLE NUMBER	MOISTURE CONTENT(%)	OTHER TESTS
0			4.5 inches Hot Mix Asphalt. 2 Lifts: 1.5" x 3" Cored on medium severity longitudinal crack. Cracked through full depth of HMA. Lifts are bonded.				
		GP	(HMA)				
1			Very dense, brown, sandy, fine, rounded GRAVEL with scattered cobbles, moist.				
			(FILL)				
2			Corehole was terminated at 1 foot below ground surface due to very dense gravel. No groundwater seepage was observed during the exploration.				
3

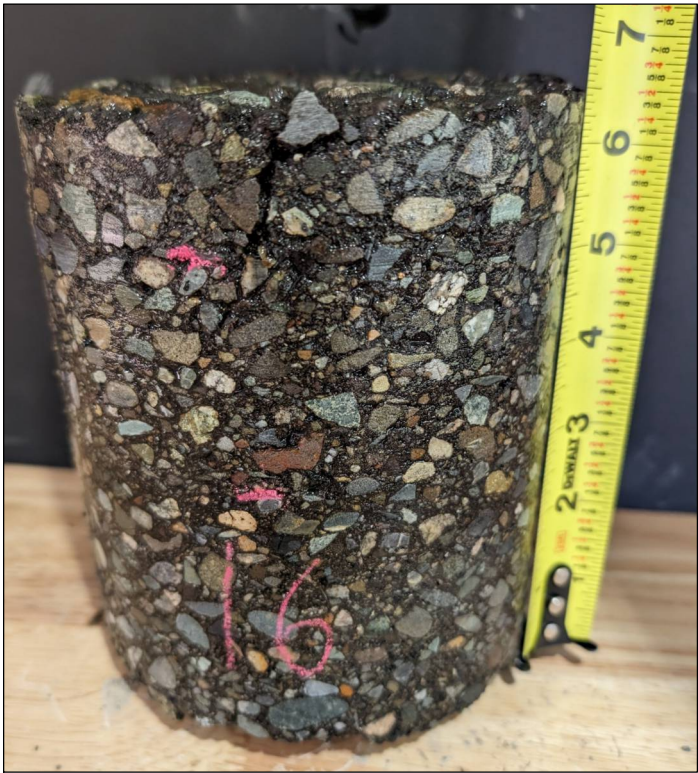
PAVEMENT CORE PHOTO

DEPTH (feet)	SYMBOL	USCS SOIL CLASS.	DESCRIPTION	SAMPLE TYPE	SAMPLE NUMBER	MOISTURE CONTENT(%)	OTHER TESTS
0			6.5 inches Hot Mix Asphalt. 3 Lifts: 1.25" x 2" x 3.25" Cored on low to medium severity longitudinal crack. Cracked through upper lift. Lifts are bonded. (HMA)				
			5.5 inches Crushed Surfacing Top Course. Very dense, brown, sandy, fine, crushed GRAVEL, moist. (CSTC)				
1		SP	Medium dense, olive brown, SAND with fine to coarse gravel, moist. (FILL)				
2			Corehole was terminated at 1.75 feet below ground surface. No groundwater seepage was observed during the exploration.				
3
