# **GORST CREEK WATERSHED STORMWATER CAPITAL IMPROVEMENT PLAN**

## **Technical Memorandum**

For: City of Bremerton, WA

September 2013

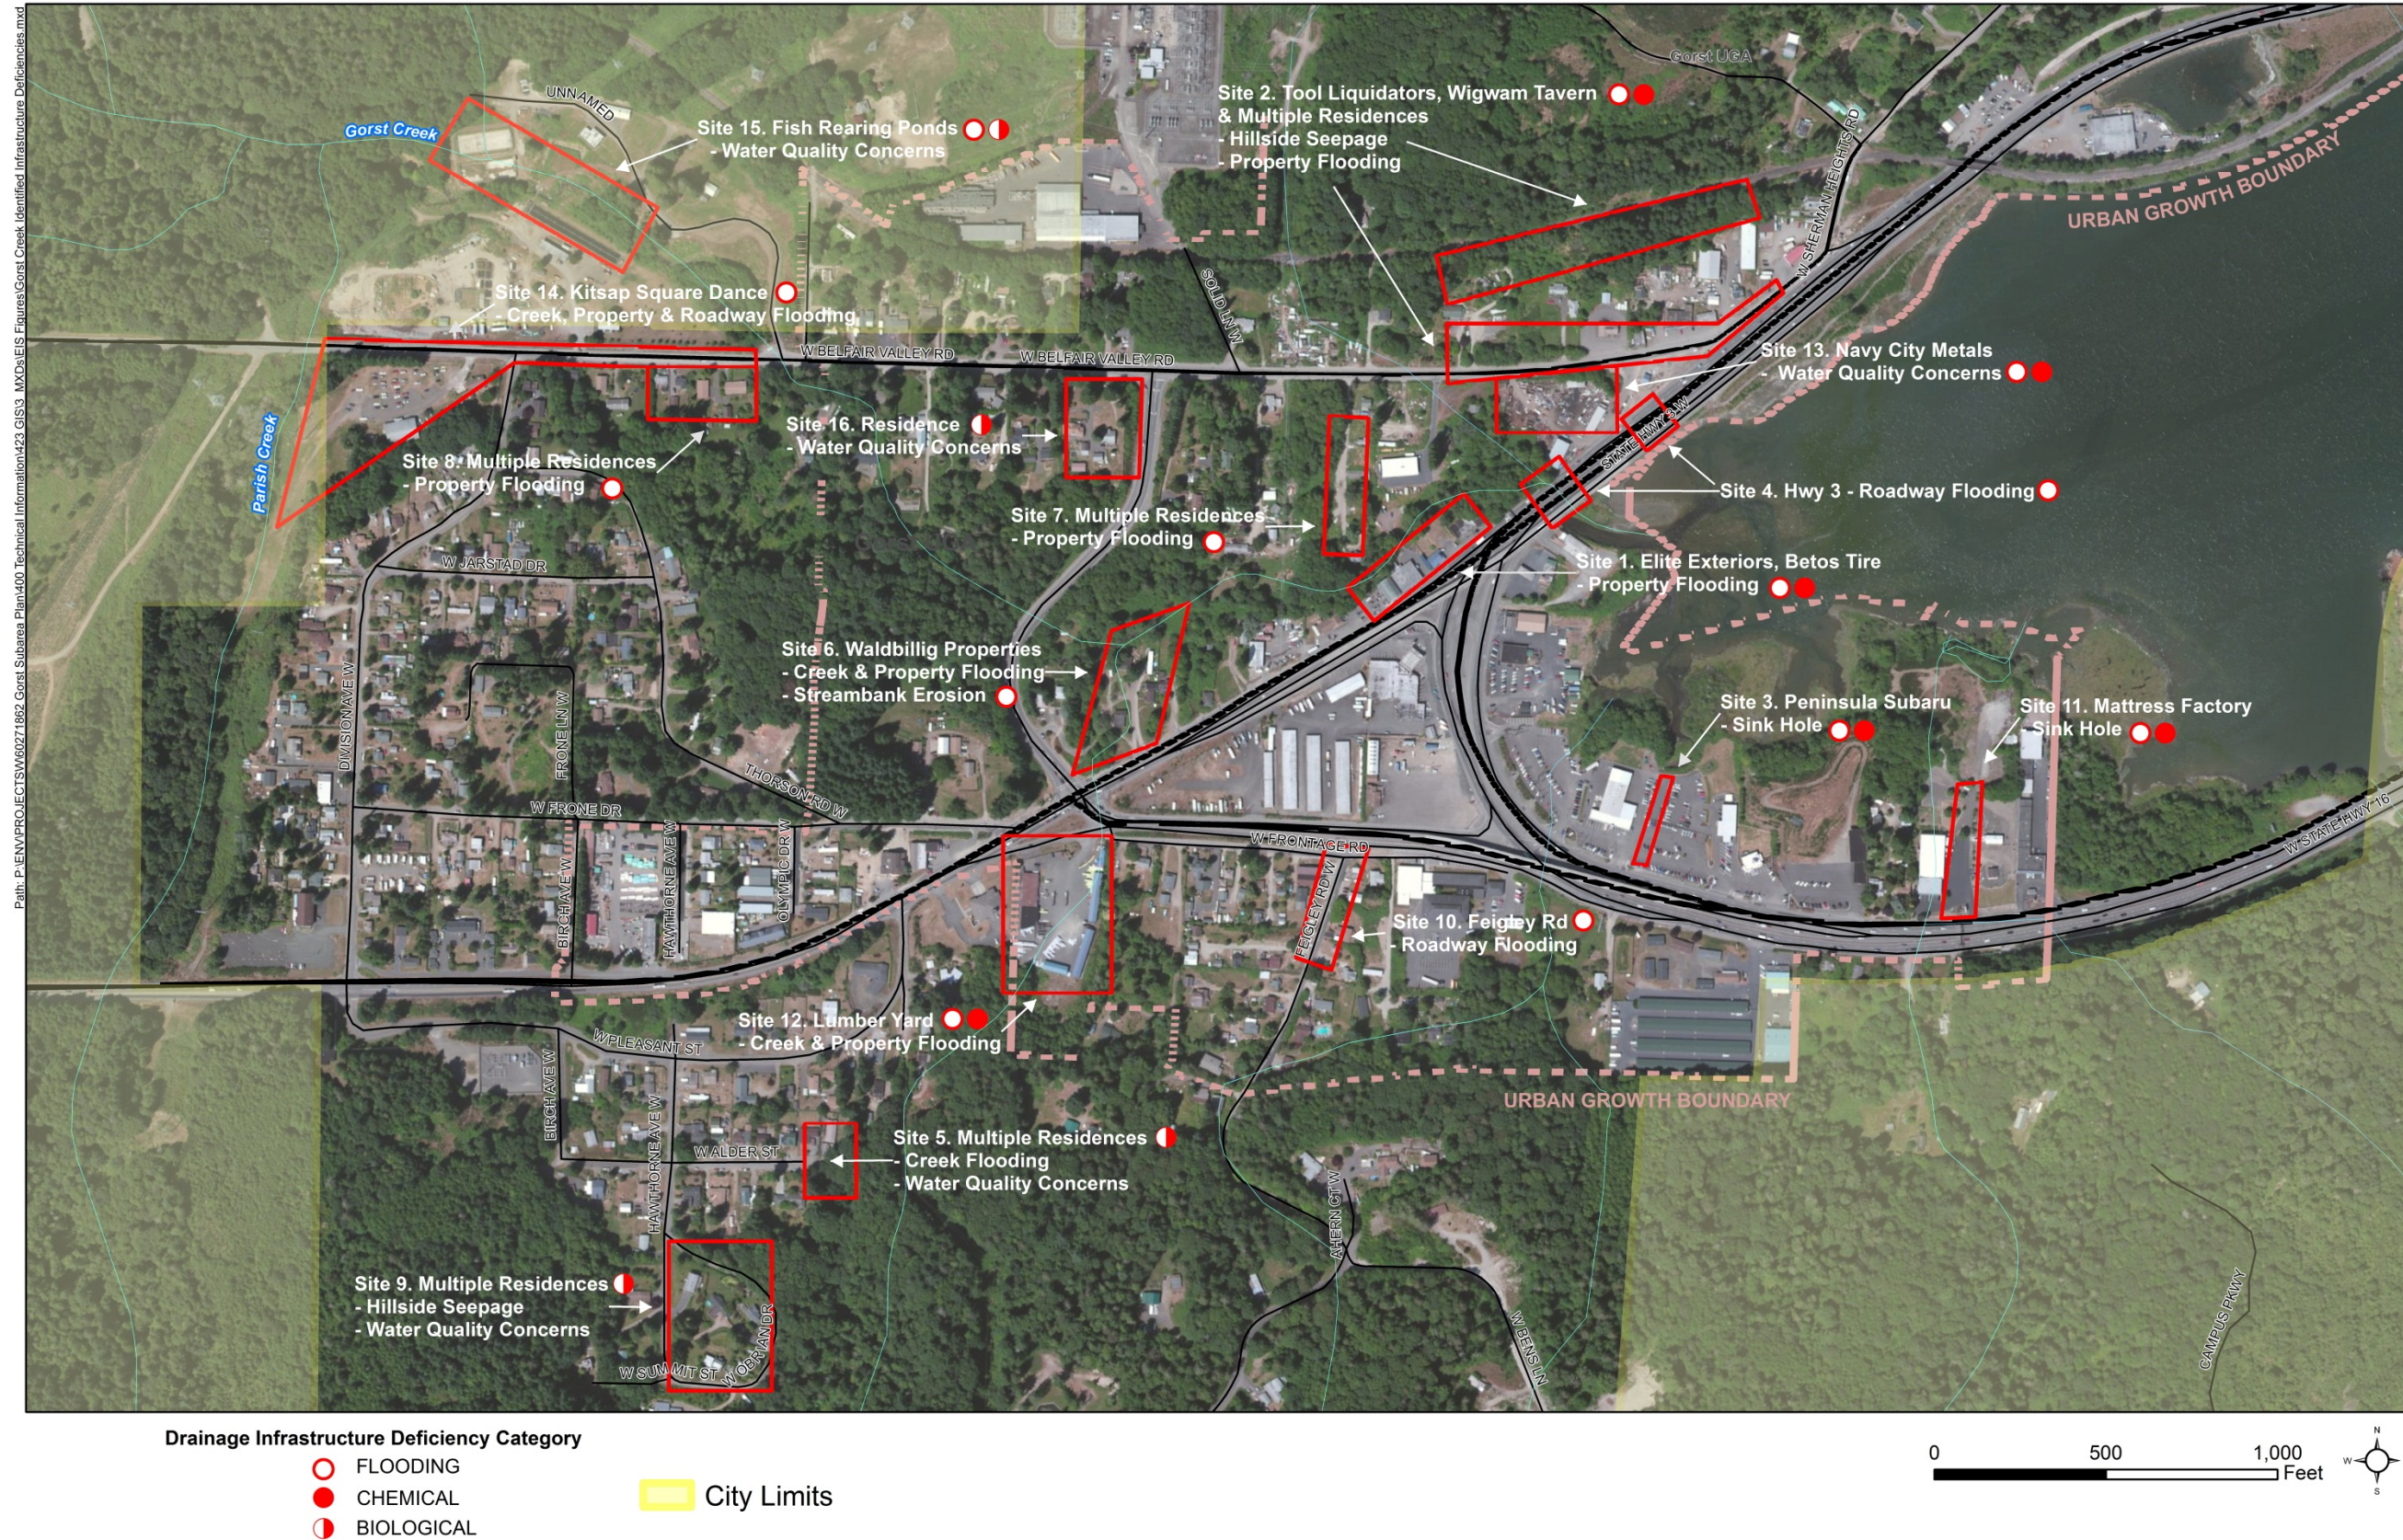
**Figure 1 - Gorst Creek Identified Infrastructure Deficiencies**  
(Fish passage deficiencies for sites 17 through 25 are not shown)

Drainage infrastructure deficiencies are identified by site and are located on Figure 1. General potential or observed deficiency concerns are provided in notes for each of the 16 sites shown on the figure. The legend identifies flooding, chemical, and biological deficiency concerns for each site. Unresolved or potential problems from drainage complaints and records are also noted for the site locations shown on Figure 1. The storm sewer systems and creeks within the Gorst UGA boundary are shown on the map in Appendix A.

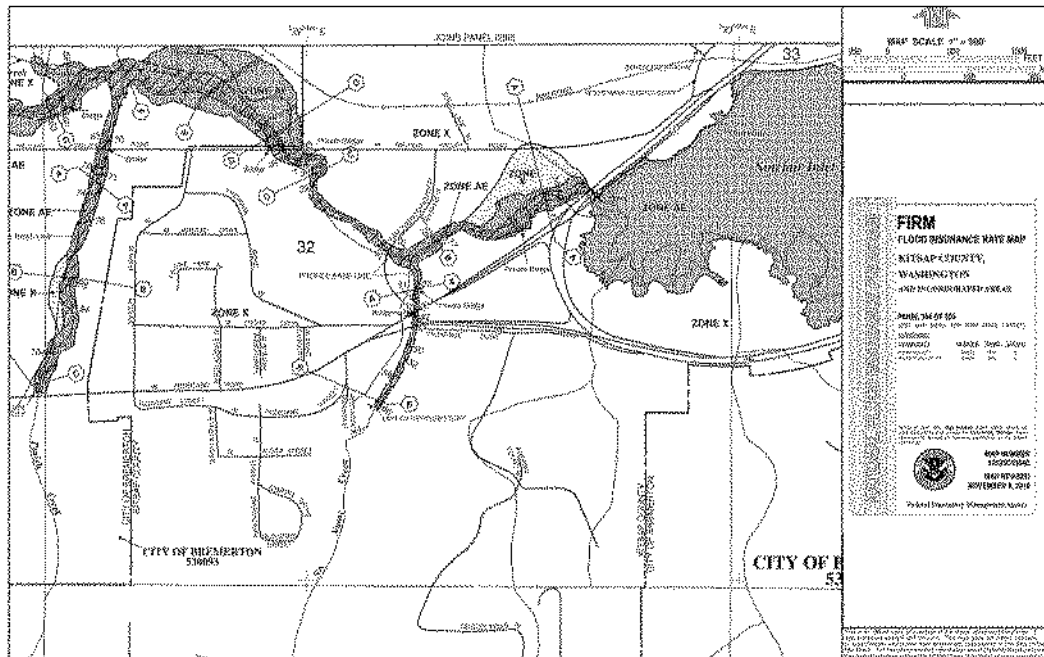
**Figure 2 - FEMA Flood Map**

Roadway runoff and property flooding as discussed in Sites 2, 7, and 13 are impacted by the flooding in floodplain areas. Gorst Creek is unable to discharge to Sinclair Inlet through the culvert during high tides and heavy rainfall events without backwater flooding in the floodplain areas. According to FEMA insurance studies, Gorst Creek has a peak 100-year NGVD elevation of 14.3 feet and record tide levels have been recorded as high as 12.9 feet. The 100-year and 500-year flood levels for the Gorst Creek Watershed are illustrated in the FEMA Flood Insurance Map shown in Figure 2.

**Discussion and Recommendations:** It is evident from Figure 2 that Gorst Creek has a huge floodplain area. Generally, as development adds impervious surface within the subbasins, creek volumes increase. Times of concentration are reduced for the peak creek flows. When Sinclair Inlet tides are high at the same time as peak stream flows are occurring, the creeks cannot drain the backwater through the outlet culverts. The inability of the backwater to drain through the culverts causes overflows onto the roadway. Three intuitive options to reduce roadway flooding include:

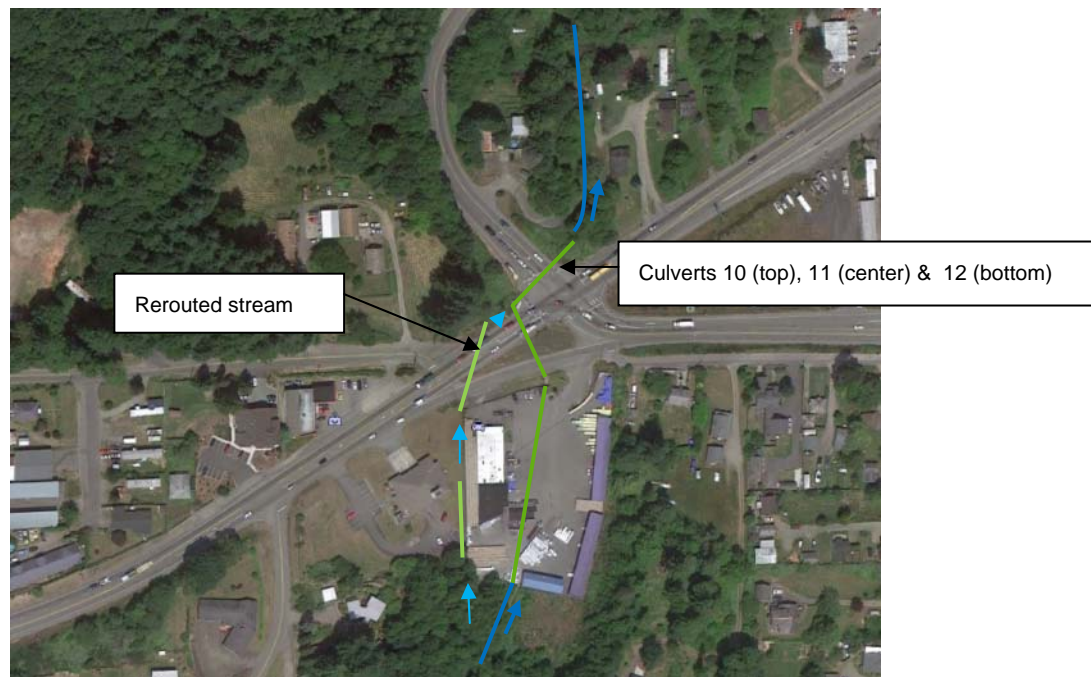
**Figure 2 - Existing Culverts of Unnamed Stream**

Length of the culvert reach cannot be addressed without redirecting the flow from this unnamed stream (1227026475270). The upstream flow traverses a total of 640 LF into three culverts that outlet into the small channel outlet shown. The 100 LF plus length of culvert crosses Sam Christopherson Road where it picks up the culvert crossing Hwy 3 from the lumber yard (addressed under Site 25) and then crosses Washington Cedar Lumber yard culvert (addressed under Sites 12 and 26). This culvert may be completed incrementally (see Figure 2).

*Estimate:* For estimating purposes, the design scope includes upstream hydrologic modeling. A biological assessment will be required as part of the HPA permit. While may be possible to clean out the sediment from the culvert, the construction scope assumes the culvert will be replaced with a rerouted 58-inch-wide arch culvert to the south side of Hwy 16 and Hwy 3. Unnamed Creek 1227026475270 will be rerouted around the west side of the Washington Cedar Lumber Yard within the fire station property.

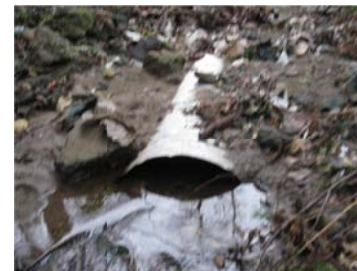
**Photo 17** Culvert 14 inlet

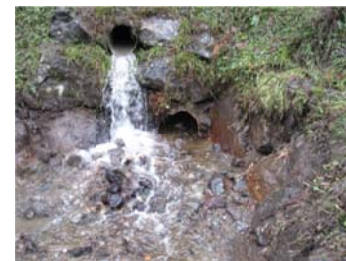
**Photo 21** Culvert #19 outlets

*Discussion and Recommendations:* Culvert length and the length of reach is not known. Replacement of this culvert is the responsibility of WSDOT.

*Estimate:* For estimating purposes, the design scope includes investigating this stream for fish habitat quality and the feasibility of improving the site to remove this fish barrier.
