# West Kitsap Way Planning Study

## Appendix A

### Existing Transportation Conditions

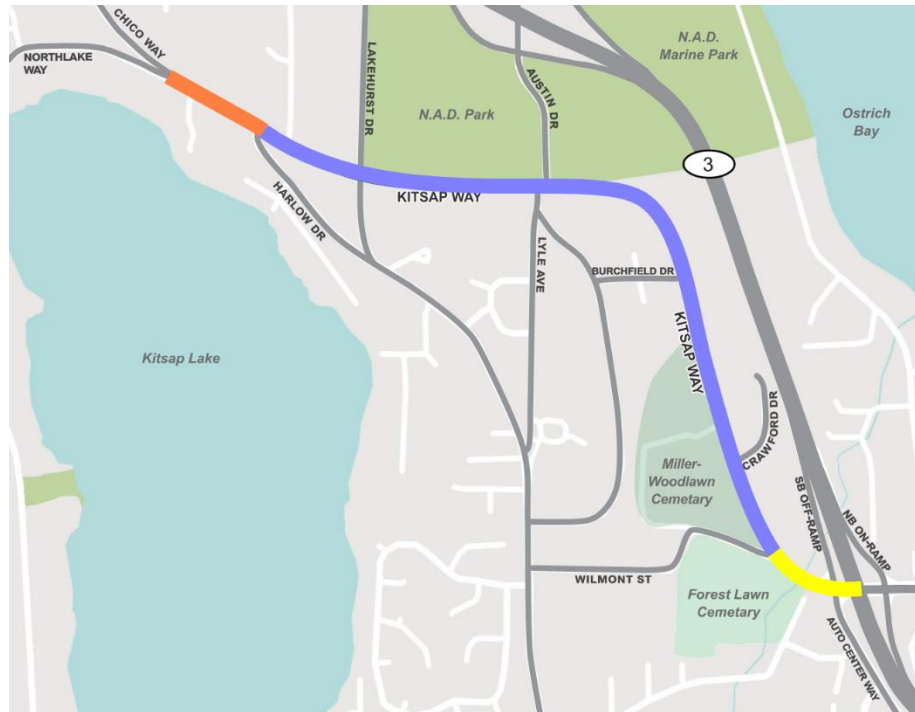
The western portion of Kitsap Way is a minor arterial street with a 35 mile-per-hour (mph) posted speed limit. There are three main segments of the corridor described below:

- ◆ **Between Northlake Way and Harlow Drive** – This segment has one-to-two travel lanes in each direction with a center turn lane to provide access to adjacent properties. This area, also known as the Kitsap Junction, encompasses the business/commercial center of the community. At the north end of the corridor, Kitsap Way splits at the Northlake Way/Chico Way intersection, becoming two-lane roadways.

- ◆ **Between Harlow Drive and Wilmont Street** – This segment is representative of the majority of Kitsap Way. The roadway has four-lane section with two 10.5-foot travel lanes in each direction and a narrow 5-foot center painted median. The lack of a center left turn lane requires left turning vehicles to stop in the travel lane while waiting for a gap in traffic. Intersections along this corridor include Lakehurst Drive NW, Austin Drive/Lyle Avenue, Burchfield Drive, and Crawford Drive. Between Burchfield Street and Wilmont Drive there is continuous 5-6 percent roadway grade for approximately half a mile.

- ◆ **Between Wilmont Street to the SR 3 Interchange** – Approaching the SR 3 Interchange intersections, Kitsap Way widens to five lanes to allow for left turn lanes at the northbound and southbound SR 3 intersections. The interchange area includes bicycle lanes and sidewalks.

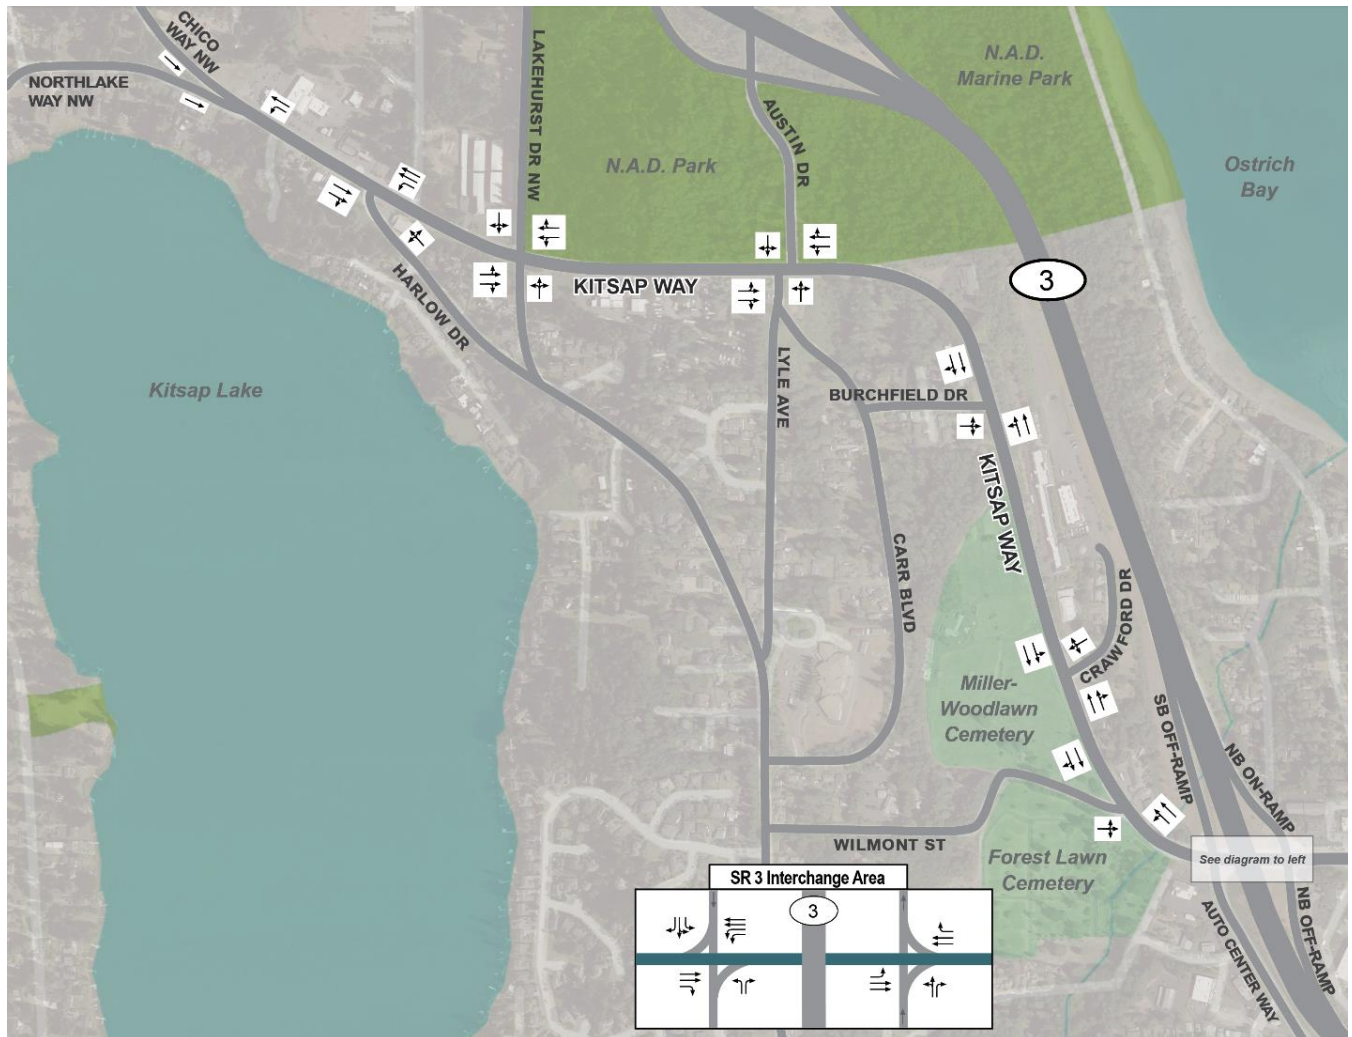
**Figure A-1. Existing Channelization**

Except for the interchange intersections, most study intersections are stop-controlled for the minor approach. The intersection at Northlake Way NW / Chico Way NW – Kitsap Way is uncontrolled, with only a yield for left turn movements from Kitsap Way to Northlake Way NW. Most corridor intersections do not have left turn lanes, requiring left turning vehicles make turns from the inner travel lane. Figure A-1 shows the traffic control and channelization for the study intersections.

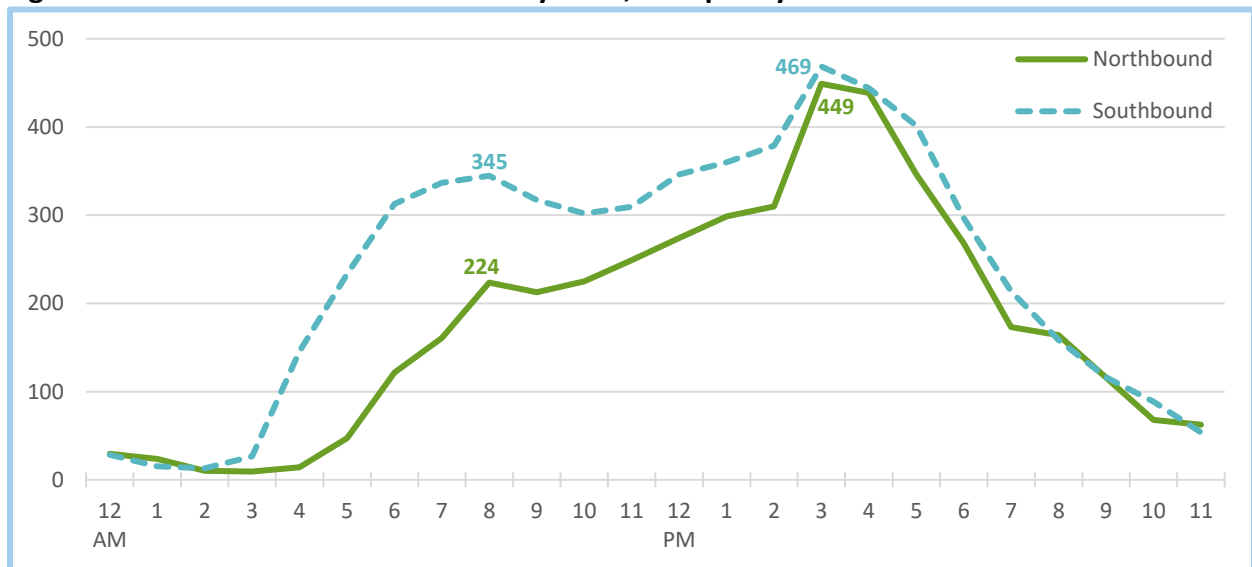
**Figure A-2: Mid-Week Vehicle Volume by Hour, Kitsap Way at Burchfield Drive**

The daily volumes can also provide information on the directional patterns of traffic flow during the day. Traffic volumes are higher in the southbound direction during both AM and PM peak hours. Total volume during the PM peak hour is 60% higher than the AM peak hour. **Figure A-2** shows the existing traffic volume profiles for westbound and eastbound traffic on Kitsap Way.

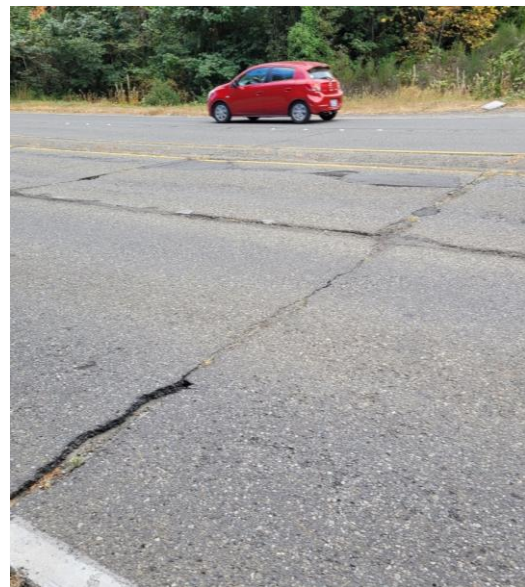
A frequent complaint about the Kitsap Way corridor is the pavement's condition. The roadway was constructed with a series of concrete panels and many of which have a fair to poor condition rating. The joints between panels create bumpy and noisy vehicle travel, and visible cracking has occurred along the joints where an asphalt overlay was applied. Pavement rankings from 2017 study show the Pavement Condition Index (PCI) ratings are all below 65 (on a 100 scale) with the worst segment just east of Austin Drive. The low PCI scores and overall roadway conditions requires roadway reconstruction and lower-cost overlay or restoration options are not viable for Kitsap Way.

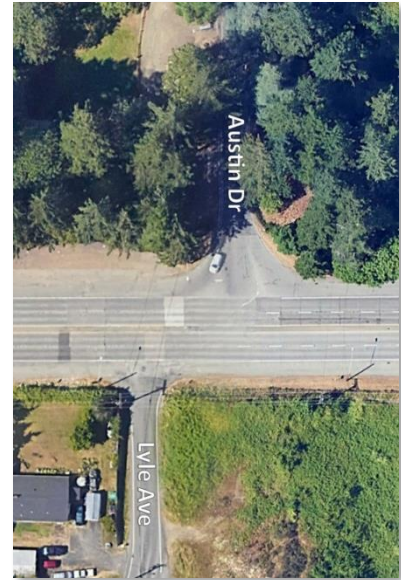
Side street approaches from the opposite direction are traditionally aligned to form a compact intersection. At the Kitsap Way/Lyle Avenue-Austin Drive intersection (shown at right), the side street approaches are offset by approximately 80 feet. While the two approaches function as a single intersection, the offset requires vehicles crossing or making left turns at the intersection to travel on a longer diagonal path, potentially reducing intersection safety and operations.

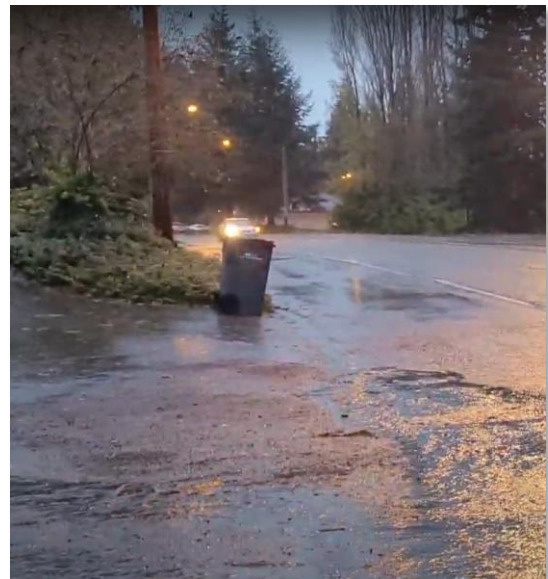
For example, the photo to the right shows limited sight distance to the north at the intersection of Kitsap Way and Burchfield Drive. Drivers must pull to the edge of the travel lane to see approaching vehicles.
